# HOME INSPECTION REPORT

70 Indian Rd

Prepared by: Bob Papadopoulos P.Eng., RHI \*

Inspection Date: May 10 2021

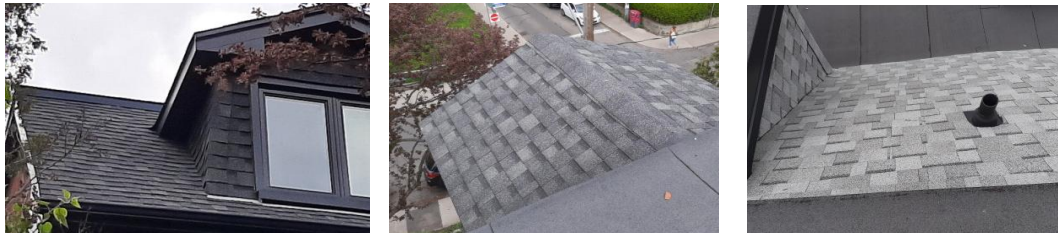
Sloped Surface: overall surface in good repair

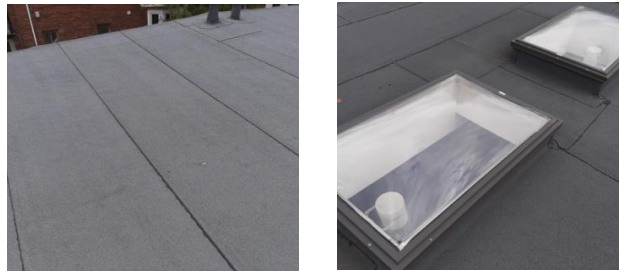
Flat Surface: overall surface in good repair

Skylight(s): newer, in good repair

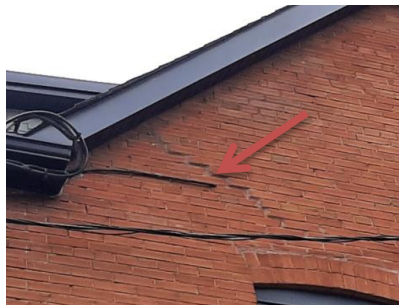
Masonry: exterior south central, older settlement crack- repaired, overall typical

Masonry Arches: minor cracks/mortar maintenance

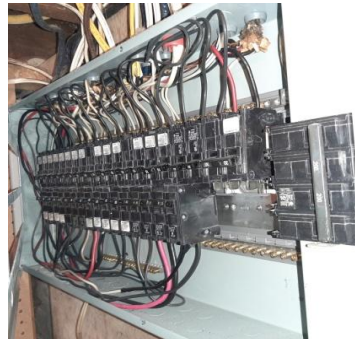
SERVICE PANEL: **overall in good repair**

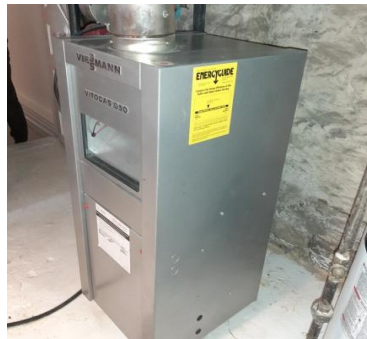
HOT WATER BOILER: service annually, overall good quality unit  
annual CO test mandatory for this type of unit
